CREW ESCAPE CAPSULE RETROROCKET CONCEPT

Volume I DEMONSTRATION PROGRAM

TECHNICAL REPORT AFFDL-TR-76-107 Volume I
FINAL REPORT FOR PERIOD MAY 1972 - OCTOBER 1975

AIR FORCE FLIGHT DYNAMICS LABORATORY
AIR FORCE WRIGHT AERONAUTICAL LABORATORIES
AIR FORCE SYSTEMS COMMAND
WRIGHT-PATTERSON AIR FORCE BASE, OHIO 45433

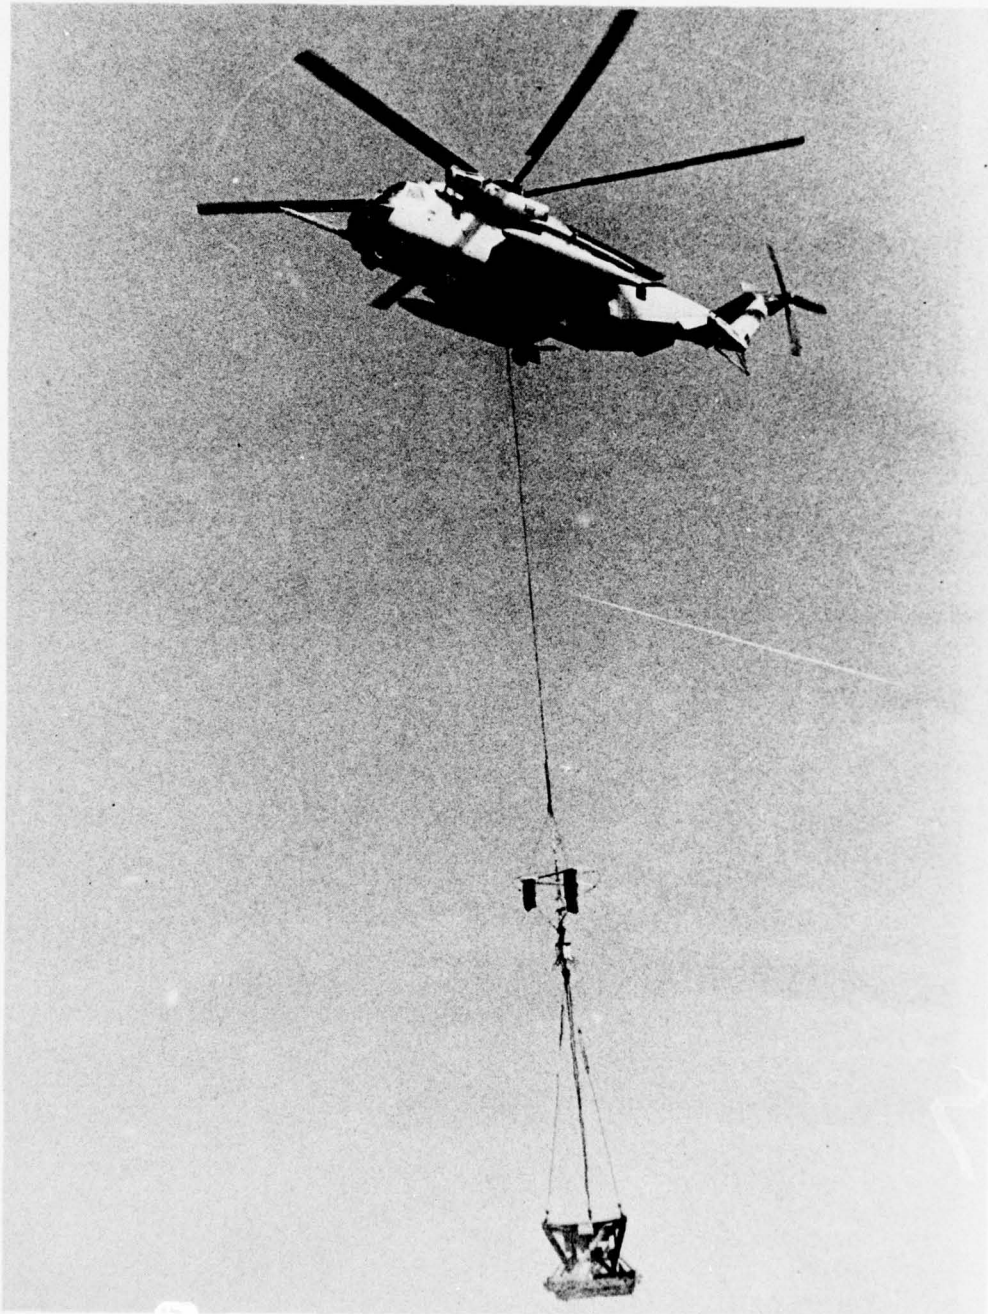
The test procedure was for the helicopter to lift the parachutes and frame from the support, followed by the rocket cluster/confluence fitting, and then pick up the test vehicle. The helicopter would climb to 2000 feet, fly one "dry run" pattern and then the test run. The test vehicle would be released at the center of the bull's-eye in the drop zone (see Figures 22, 23, 24 and 25). The sequence should be as follows:

- a. Before release - the helicopter operator switches on the telemetry, the on-board cameras and the power arm switch, then releases the vehicle by pushing in the release switch.
- b. At release - the electrical cable is disconnected, the safe-and-arm device is actuated, the F-1B timers are actuated and the parachutes start to deploy.

- f. Forty seconds after release - at approximately forty seconds after release, the probe tips impact the ground, firing the CDF initiator, the CDF lines and the rocket motors in turn. The rocket motors burn for approximately 0.4 second for maximum thrust and approximately 1.0 second for the sustainer thrust. The vehicle will impact the ground during sustainer burning or immediately thereafter.
